THE RED WING CROOME COURT

An Interim Report on its Structural Evolution
and Historic Uses

February 2012

Prepared on behalf of the National Trust

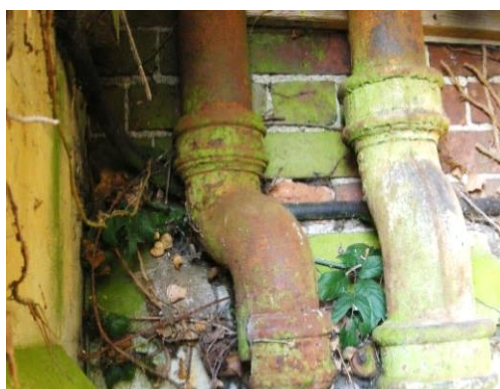
Figure 21 Detail of rainwater goods
on south elevation (Author)

The windows are generally regularly spaced and are all glazing bar sashes of varying size and date (See Appendix V). The dormer windows are all three over six panes. There is a roof light to the internal staircase in the north range.

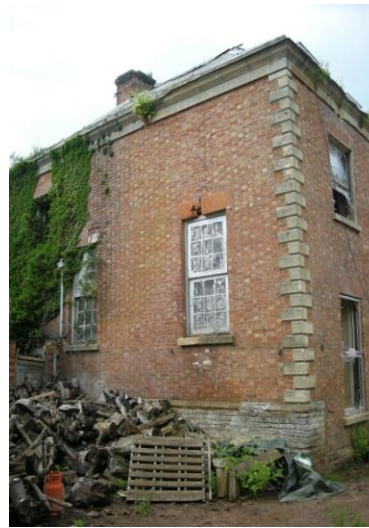
Figure 23 South-east corner (Author)

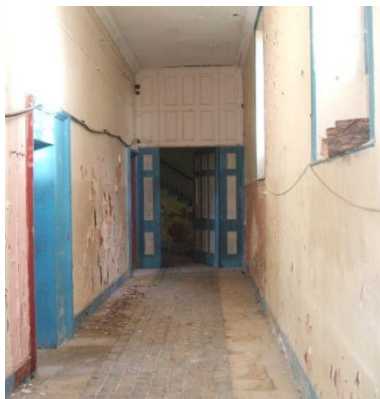
Figure 24 Passageway on ground floor of link range (Sally Sutton)

The passageway (G3) to the south is lined with stone flags, the central ones of which were replaced with blue bricks in the mid 19th century, similar to those in the basement of the mansion house. The walls are plastered and have a simple cornice and the doorways to the north side are mid 18th century and original but with some 20th century alterations. Along the south side are a run of large windows set high in the wall. The openings have been altered and the sills lowered in the four westernmost windows. At the eastern end of the

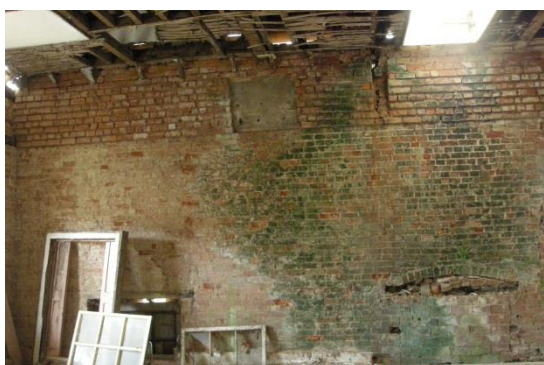
Figure 29 South wall of first-floor corner room (F12) showing raised ceiling (Author)

Like the ground-floor, there is a large room in the south-eastern corner (F12) which has a close-boarded oak floor, plastered walls and an ashlar chimneypiece of good quality with a central keyblock. To the right of the fireplace is a tall blocked archway, similar to those in the passageway, and the alcove to the left of the fireplace has been infilled, partly to box in the flue to the brick oven beneath. This room contains much evidence of the wing's complex structural history. The ceiling has been raised around 0.8m above its original height and the roof above altered and repaired with new pine trusses. The repairs are likely to be due to

defective parapet guttering that caused water ingress and consequent decay of both the roof structure and attic floor above. They appear to be mid 19th century in date and were probably part of the mid 19th century phase of work that occurred after the death of the 8th Earl. Certainly no room is shown on the attic floor above in either the 1940 or the 1968 plans. The walls have been stepped or corbelled out from the wall face to form a deep coving with the former dormer windows adapted to form top lights. There were further repairs and alterations undertaken to the brickwork in the mid 20th century when the steel beams evident in this part of the building were also inserted to help reinforce the fabric. This could have occurred during the 1930s or during the school period, when the room was subdivided and part of it used as a sanatorium. It is believed that the room was again altered during the 1980s to accommodate a mezzanine storey. Further research is required to clarify these phases.

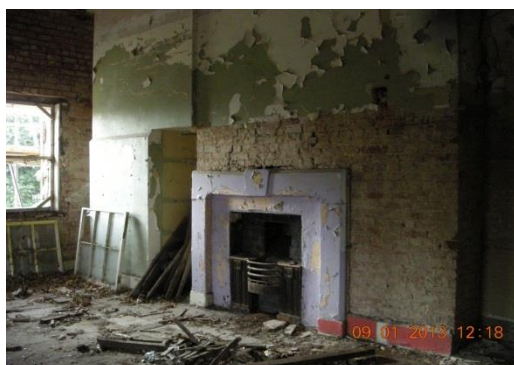
Figure 30 West wall and chimneypiece in F12 (Author)

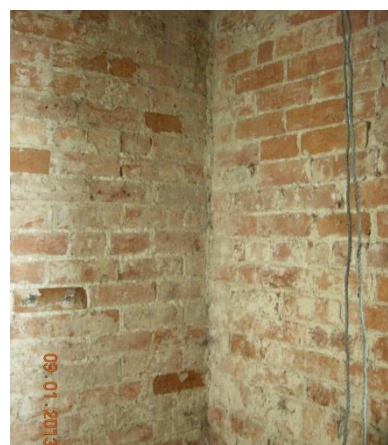
Figure 31 Straight joint visible in SW corner of F18 (Author)

In the rooms flanking the passageway in the north range, straight joints are visible where the external walls adjoin the link range. The wall that separates the north range from the passageway appears never to have been finished as an external wall but always intended as an internal partition. A reused 17th century timber beam, the only one in the building of this date, has decayed and fallen into F18.

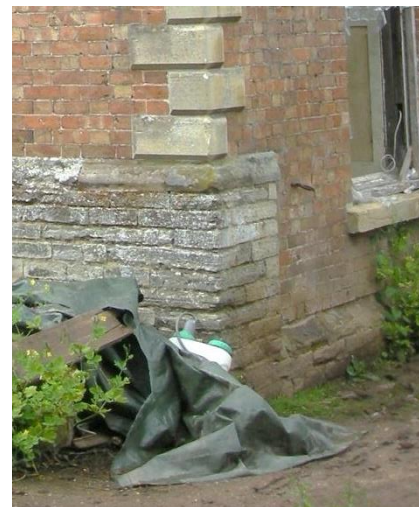
Figure 33 Detail showing plinth at SE corner (Author)

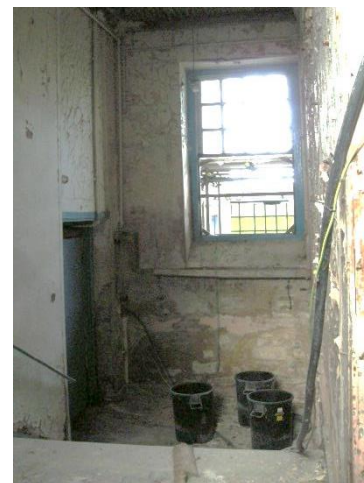
Figure 35 Large sash window at W end of N elevation with C18 door into basement on left (Author)

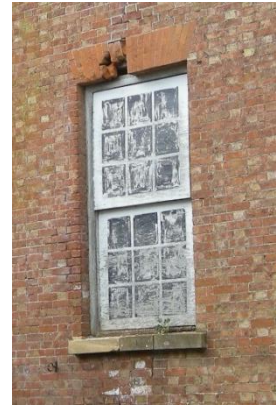
Figure 36 Blocked sash window to SE (Author)
